# DAM INSPECTION CHECKLIST POSSUM POINT POWER STATION POND ABC

INSPECTION DATE: FEB. 2, 2016

INSPECTED BY: K. ACREE

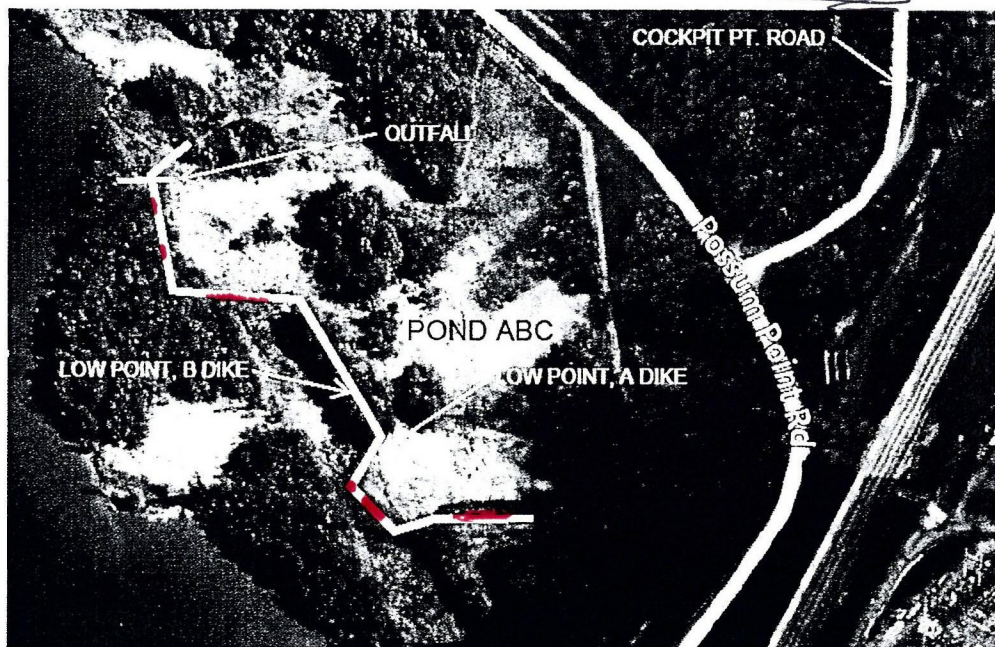
\* See figure below.

Location/ Condition	(y/n)	Change (y/n)	Comments
Low Point, A dike*			
Flow	N	N	1523 -> SAND BAGS & RIGRAP IN PLACE, WITH SEVERAL SAND BAGS THAT ARE RIPPED
Erosion	N	N	NO STANDING WATER AGAINST SAND BAGS
Low Point, B dike*			
Flow	N	N	1528 -> SAND BAGS ARE IN PLACE AND SEVERAL SAND BAGS ARE RIPPED,
Erosion	N	N	NO STANDING WATER AGAINST SAND BAGS
Outfall water surface El. (top of stoplogs to water)			1533 -> NO STANDING WATER AGAINST WEIR, NO FLOW THROUGH WEIR, AND THE WEIR APPEARS TO BE DRY.

**Additional Comments (Note any changes observed along the embankment crest or downstream slope observed from the crest.):** - LOW POINT, (DIKE) SAND BAGS IN PLACE, SEVERAL SAND BAGS ARE RIPPED, AND THERE IS NO STANDING WATER AGAINST SAND BAGS  
- POND A HAS ~~water~~ <sup>STANDING</sup> WATER AT INSIDE TOE OF EMBANKMENT (TYPICAL OF PONDS B & C)  
- STANDING WATER AT TOP OF EMBANKMENT OF PONDS (AS NOTED BELOW)  
- ~~STANDING WATER AT TOP OF EMBANKMENT OF PONDS (AS NOTED BELOW)~~ KMA 2/3/16
